STREAM ECOSUMMARY

Snell Creek, WBID 1472A
Polk County
STORET Station TP607Snell
April 22, 2010 and October 20, 2010

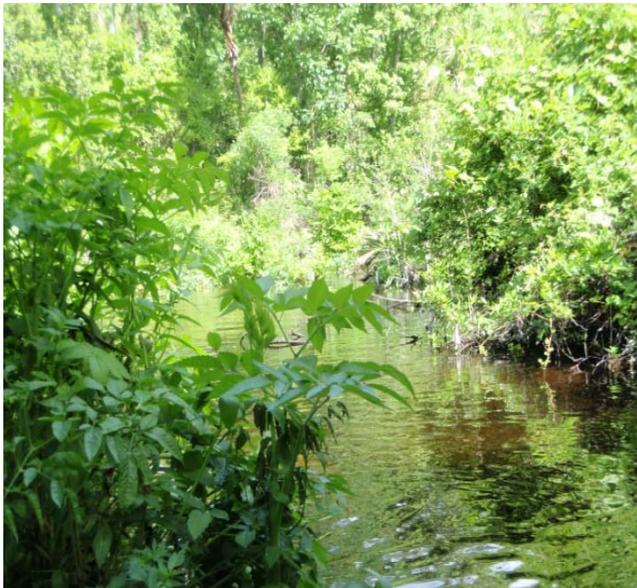
Figure 1. Photo of Snell Creek SCI station.

The riparian zone was mostly natural and quite extensive, about 70 meters on the west side and several hundred meters wide on the east side. The in-stream habitat in this section of Snell Creek was predominantly sandy bottom. In April, there were four productive habitats comprising 24% substrate available for invertebrate and fish use (snags, roots, aquatic vegetation and leaves). In October leaf habitat had been washed out by the summer rains and only three productive habitats were present; approximately 6% was available for invertebrate and fish use (snags, roots and aquatic vegetation). Less than 25% of the habitat was smothered by either sand or silt accumulation and water velocity was 0.25 meters per second on both sampling days.
