Lake Buckeye Water Quality Management Plan

Prepared for:
Polk County Parks and Natural Resources Division

September 2015
Draft Final

ATKINS

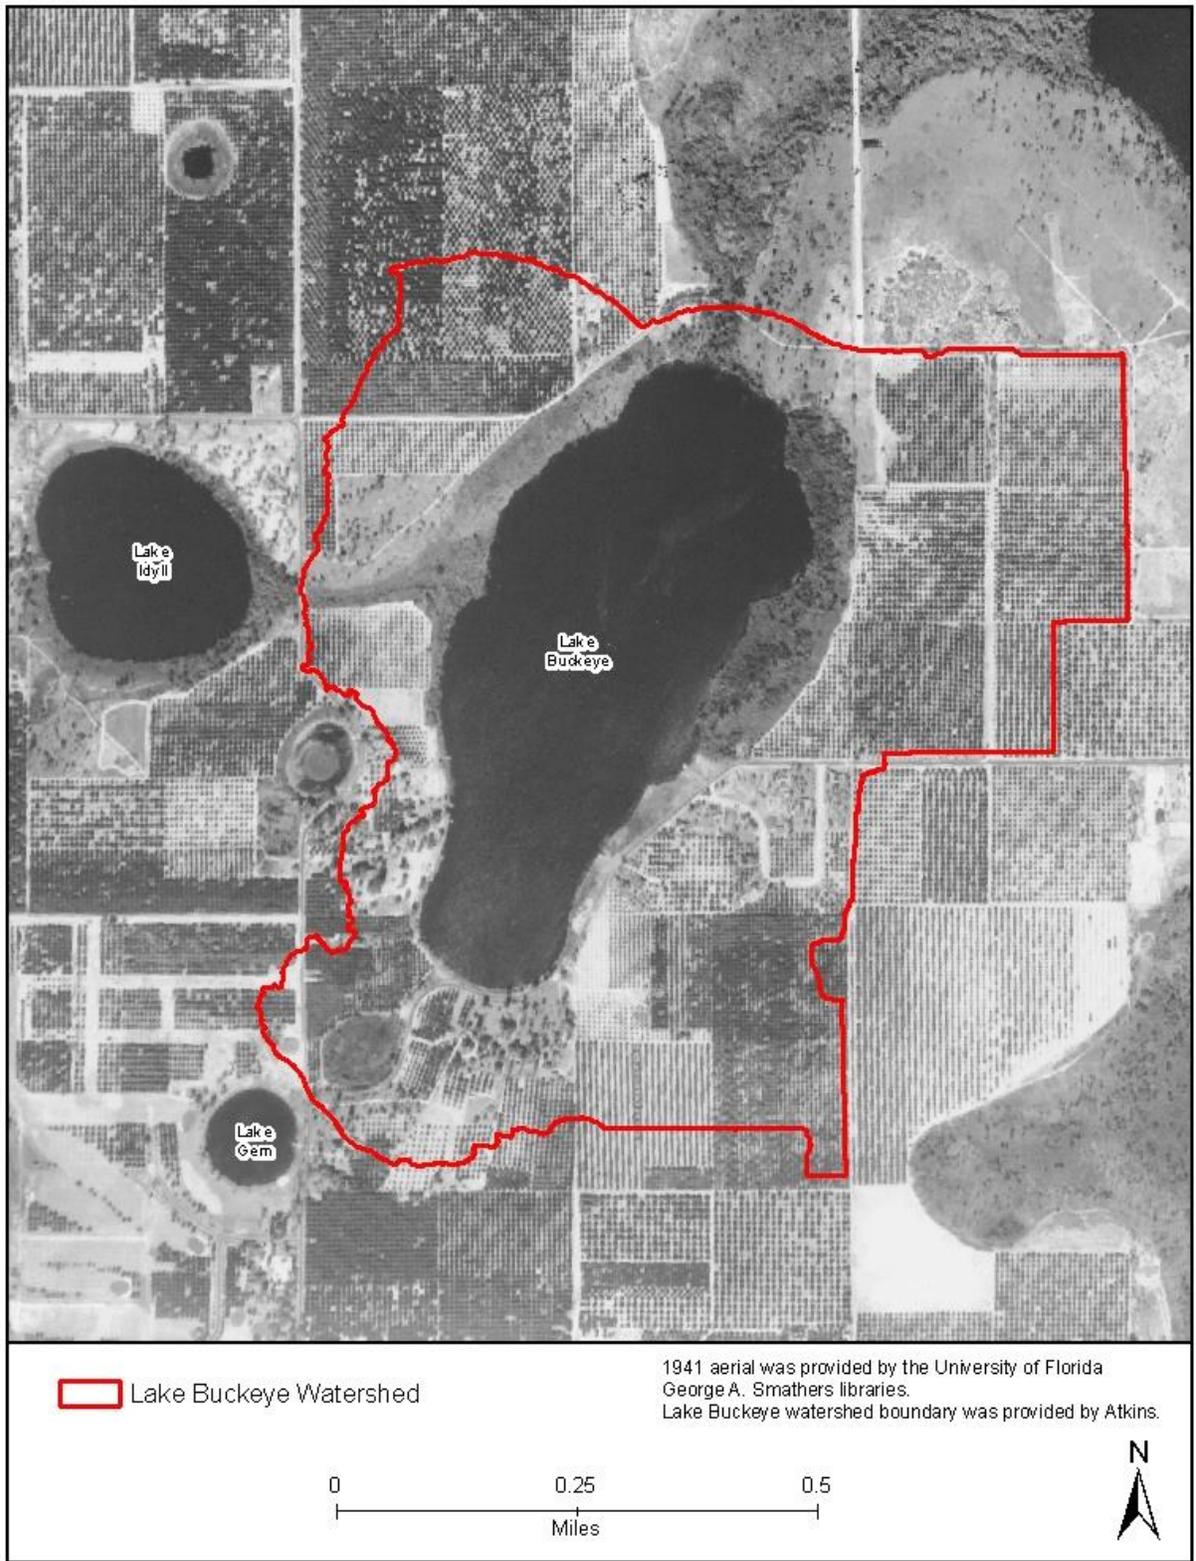
Figure 3-2 Historical Aerial (1941) of Lake Buckeye and Adjacent Watershed.

Lake Buckeye is located in central Polk County within the City of Winter Haven (Figure 3-1) at an elevation of 123 feet NAVD. The lake occurs within the Winter Haven/Lake Henry Ridges lake region of Florida which according to Griffith et al. (1997) contains small to medium sized lakes that can be “characterized as alkaline, moderately hard-water lakes of relatively high mineral content, and are eutrophic” The lake is hydrologically connected to Lakes Idyl and Gem and discharges to Lake Fannie through a slough along the north-eastern portion of the lake. A review of historical aerial photography (1941) indicates that the shoreline has been

modified compared to recent (2011) photography (Figures 3-2 and 3-3). The most extensive wetland extent is located along the northern rim that is part of the slough system which interconnects Lakes Buckeye and Fannie.

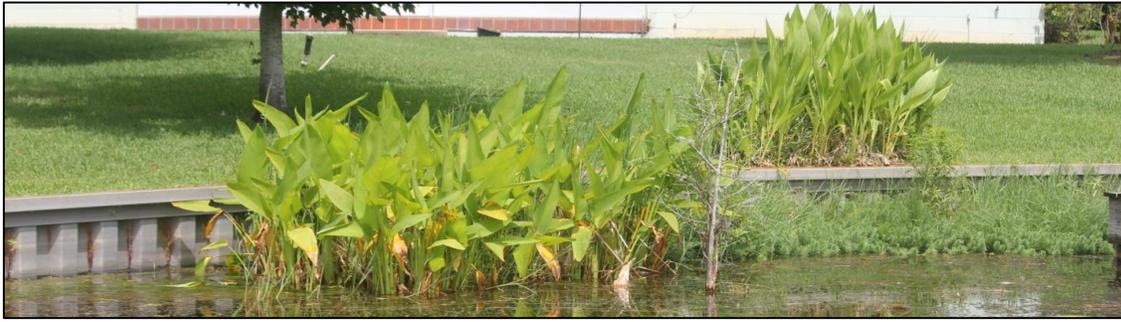
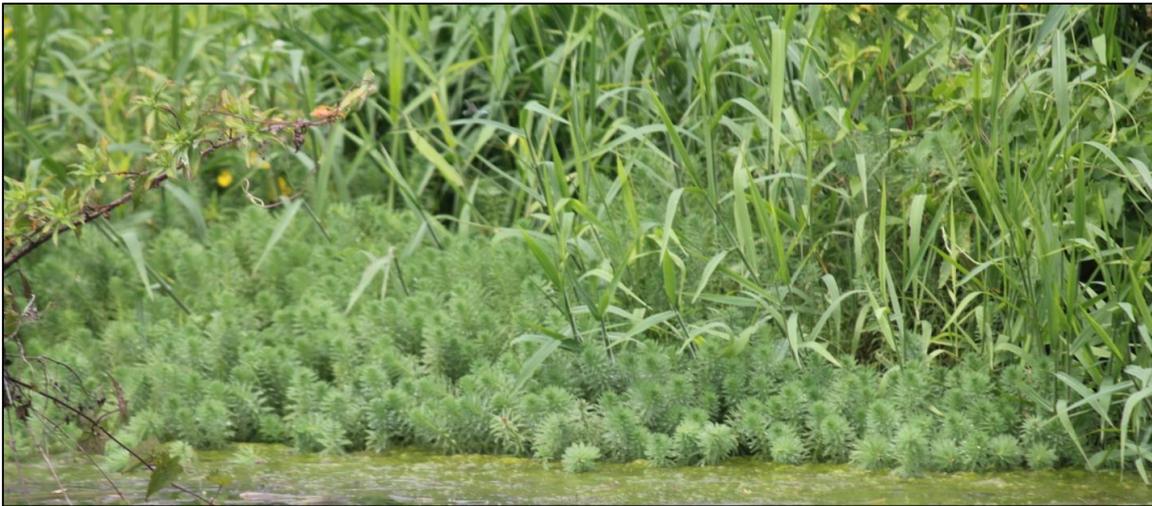
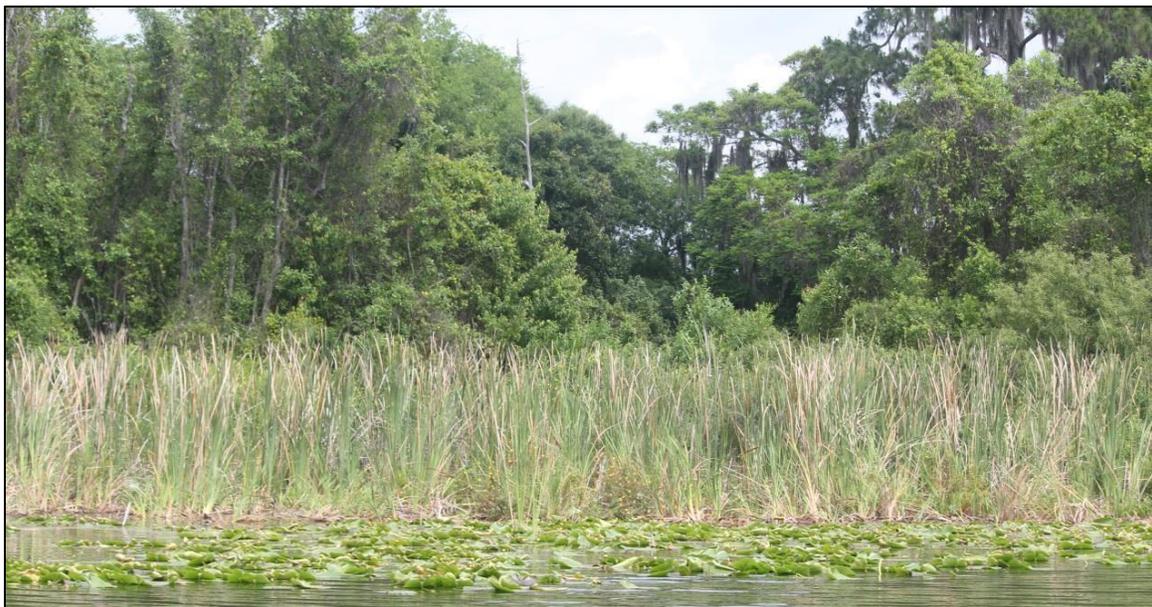
Figure 3-7 Photographs of Lake Buckeye shoreline. Top: hardened shoreline. Middle: shoreline with mixture of native and exotic vegetation. Bottom: wetland extent at connection to Lake Fannie

A western portion of the shoreline has been modified as a result of residential encroachment which included landscaping activities and hardened shorelines (Figure 3-7). The majority of the lake shoreline receives limited maintenance for exotic and nuisance vegetative growth due to the amount and composition of existing nuisance and exotic submerged and emergent vegetation (Figure 3-7). The only evident region of wetlands is present at the connection to Lake Fannie (Figure 3-7).

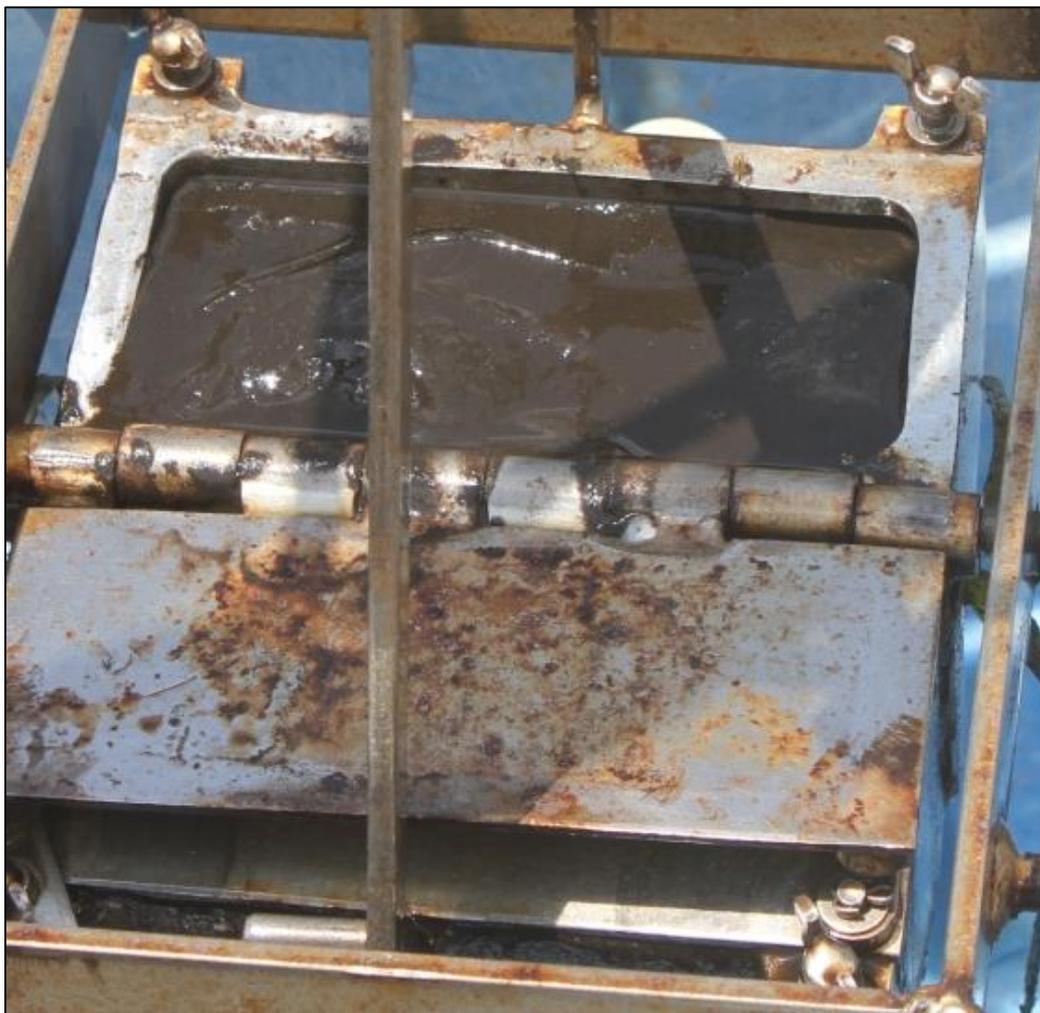
Figure 4-5 Representative Sediment Sample Collected from Lake Buckeye.

In addition to available nutrients within the water column, lake-bottom sediments can be responsible for substantial nutrient additions under anoxic conditions. Phosphorus flux via sediments can sustain eutrophication of a lake even when external phosphorus loads have been reduced or eliminated (Larsen et al. 1979, Ryding 1981). Sediment phosphorus release can occur through two mechanisms: 1) dissolved phosphate diffusion into the water column, and 2) the release of sediment pore water phosphorus or release of phosphorus adsorbed to sediment particles into the water column. Phosphorus release into the water column has been attributed to redox status and phosphorus concentration gradients at the sediment-water interface (Penn et al. 2000). As part of the lake characterization completed during an April 2015 site visit, four lake-bottom sediment samples were analyzed for percent solids and nutrient composition to assess the potential nutrient pool (Figure 4-5). Pockets of unconsolidated detrital material were identified which exceeded 5 feet in depth in portions of the lake.

On average, the sediments had greater moisture content (59 percent) compared to solids (41 percent; Table 4-1), supporting the assessment of predominantly unconsolidated sediments. The dry nutrient concentrations were lower than those reported for other lakes in Polk County (eg., Haines, Rochelle, Smart and Conine; PBSJ 2008) and those documented by ERD (2007) in Lakes May, Shipp and Lulu. While a substantial quantity of organic material was present in the bottom of Lake Buckeye, sufficient data on dissolved oxygen
