Lake Daisy Water Quality Management Plan

Polk County Parks and Natural Resources | August 2015

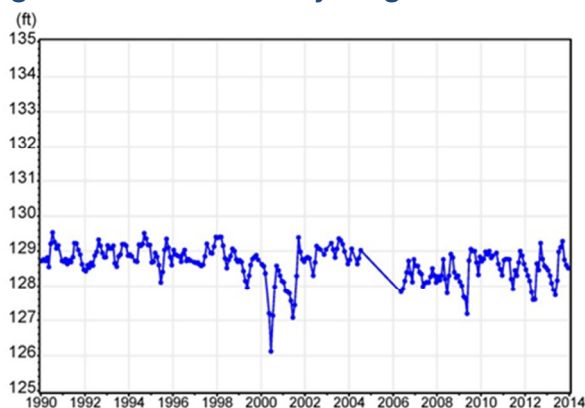
Figure 2-3 Lake Daisy Stage

The mean monthly lake stages are presented in Figure 2-3. Lake stages did not display temporal variation similar to that observed in rainfall. Stages typically ranged from 128 to 129.5 feet. The lowest lake stages did follow the low rainfall that was observed during the drought years of 2000 and 2001 and in 2009.

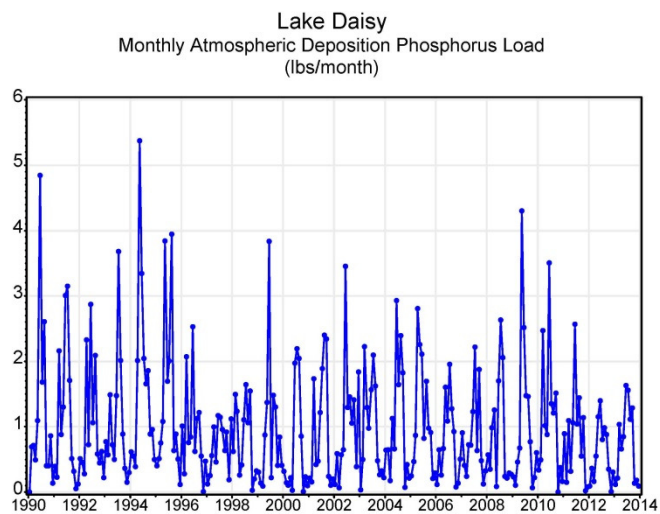
Figure 2-14 Lake Daisy Monthly TP Loadings

Typical monthly TP loads from direct runoff ranged from 10 to 20 lb/month, from atmospheric deposition were less than 2 lb/month, and from septic tanks were less than 2 lb/month. The TP loadings closely followed the temporal trends in rainfall especially during periods of elevated rainfall. As for the TN loads, the step trends in septic tank TP loadings was, again, due to the increased number of housing units.

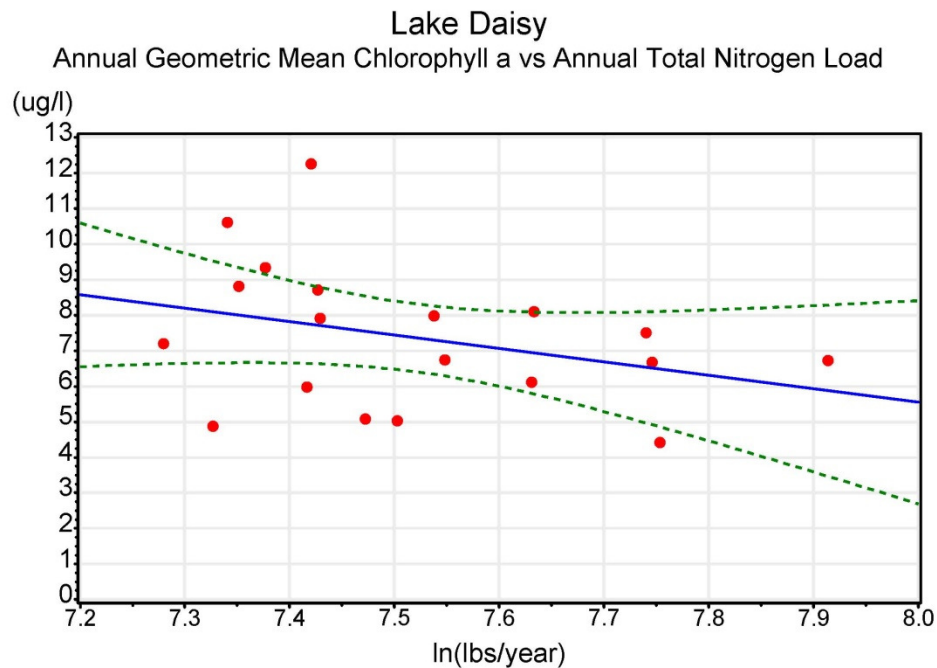
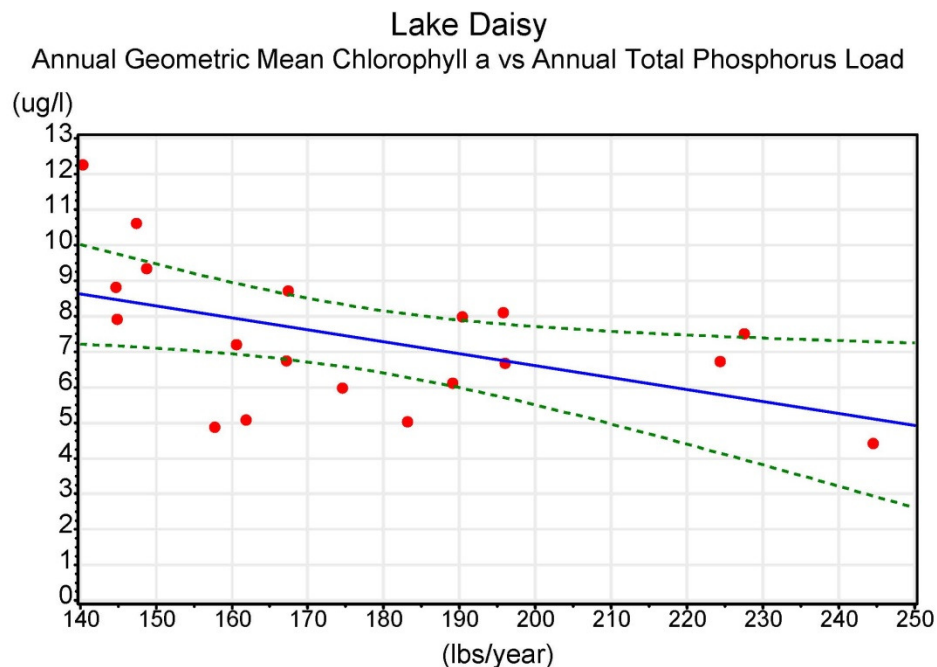
Figure 3-1 Relationship Between Annual Geometric Mean Chlorophyll a Concentrations and Total Annual TN (Top) and TP (Bottom) Loadings

As discussed above, lake residence time can be a major determinant of algal production. Since TN and TP loadings are highly correlated and each is highly correlated to the hydrologic loadings, perhaps these negative relationships can be explained by the interannual hydrologic loading variations. Simple logic applies – lower chlorophyll *a* concentrations should result during years with short residence times that result from higher hydrologic loadings. Therefore, the relationship between the annual geometric mean chlorophyll *a* concentrations and annual hydrologic loadings should be negative. Figure 3-2 presents the relationship between the annual geometric mean chlorophyll *a* concentrations and annual hydrologic loadings for Lake Daisy and displays a clear, significant relationship. The R^2 is 0.19 and the slope is significant at $p < 0.05$.

Regression Equation:

$$\text{geochla} = 35.75375 - 3.775124 * \log_{10} \text{ld}$$

$$\text{geochla} = 13.31251 - 0.033533 * \text{ann_tload}$$

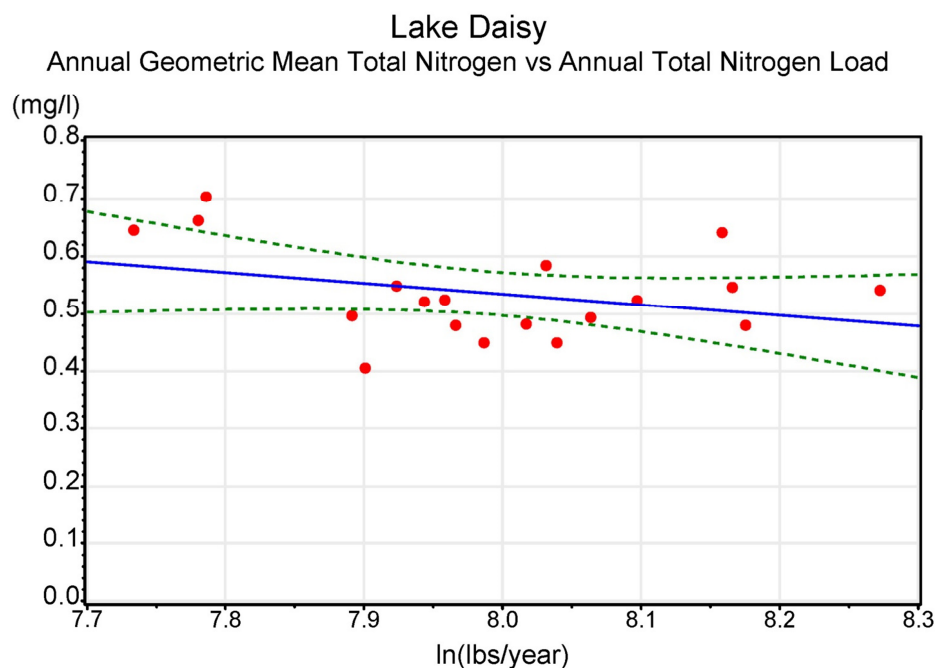
Figure 3-4 Relationship Between Annual Geometric Mean TN Concentrations and Total Annual TN Loadings (Top) and Annual Geometric Mean TP Concentrations and Total Annual TP Loadings (Bottom)

Regression Equation:
 $geotn = 2.013619 - 0.184902 \cdot \logtnld$

Regression Equation:
 $geotp = 0.11062 - 0.013415 \cdot \logtpld$

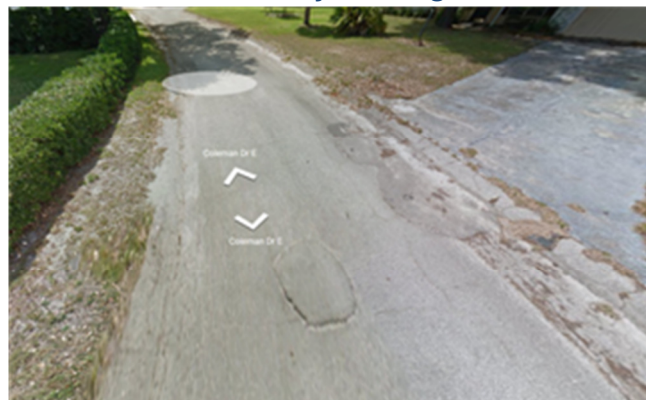
Figure 4-1 Lake Doll Neighborhood Roadway Drainage

The neighborhood around Lake Doll is served by a 22-foot wide (typical) road with asphalt curb. This BMP includes grading depressional areas within the 50-foot right-of-way as well as providing curb cuts to allow road runoff to percolate into the surrounding, sandy soils. This BMP may also alleviate standing water, which appears to be a prevalent problem - evidence of standing water degrading the road is evident at multiple locations in this neighborhood (Figure 4-1).

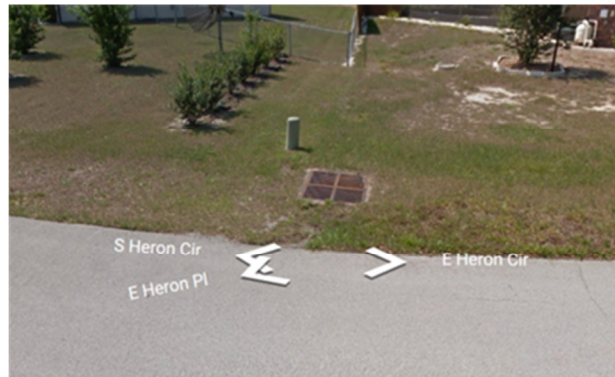
Figure 4-2 Roadway Drainage Along Heron Court

These neighborhoods also contain storm structures where grading can be accomplished to encourage percolation, such as the location shown in Figure 4-2 along Heron Circle. All grading would be performed above seasonal high water elevation, creating a depression that would allow time to percolate runoff. Excessive flows would discharge as they do now through the grate of the ditch-bottom inlet. Since the control elevation (grate top) would not be altered, this BMP could be constructed without impacts to local flood stage.

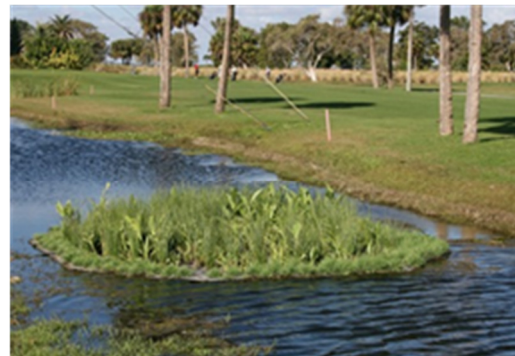
Figure 4-3 Floating Wetland

1. The finger canal at the north end of the lake just east of Lake Doll and south of Lake Daisy Road.
2. Lake Doll littoral areas.
3. The channel connecting Lake Daisy and Lake Doll.
4. On floating wetlands, such as Beemats (Figure 4-3).

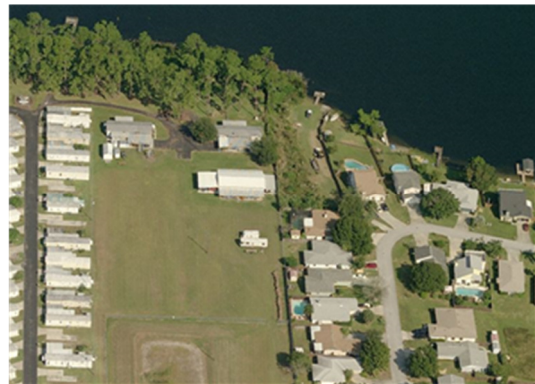
Figure 4-4 Old Grove Shores and Surrounding Properties

This BMP involves installing and monitoring two shallow monitoring wells to evaluate impacts to groundwater potentially originating from the Old Grove Shores facility. One well would be installed up-gradient of the facility in the Struthers Road right-of-way, and the second well would be installed down-gradient of the facility. The Lake Daisy Estates Home Owners' Association owns the long, slender parcel adjacent to the Old Grove Shores site down-gradient of the Old Grove Shores Facility (Figure 4-4).

Section 4 described a monitoring program consisting of installing and monitoring two shallow monitoring wells to evaluate impacts to groundwater potentially originating from the Old Grove Shores facility. After further consideration, our current recommendation is to conduct a groundwater quality screening sampling event, as a less formal way to look further into potential impacts.

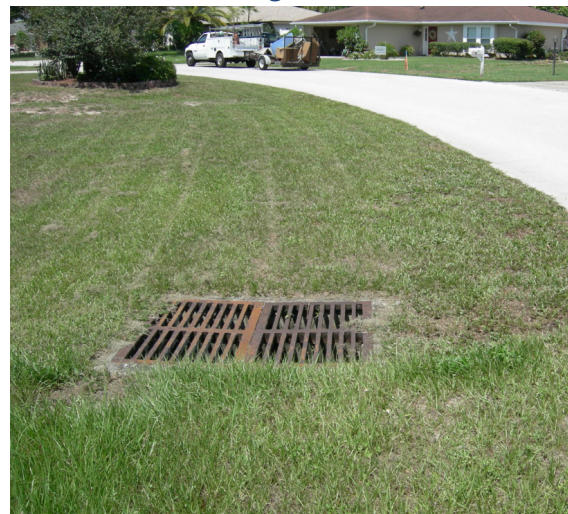
**Figure 5-4 Roadway Drainage
Along Heron Court**

Another “non-typical” condition exists near Heron Circle (BMP No. 11, shown in Figure 5-4) where a percolation area could be designed

around an existing ditch-bottom inlet. This percolation area would be constructed around the inlet. Like the typical percolation areas, the depth should be shallow. The existing grade would be maintained around the structure for safety and slope down at an approximately 6:1 slope.

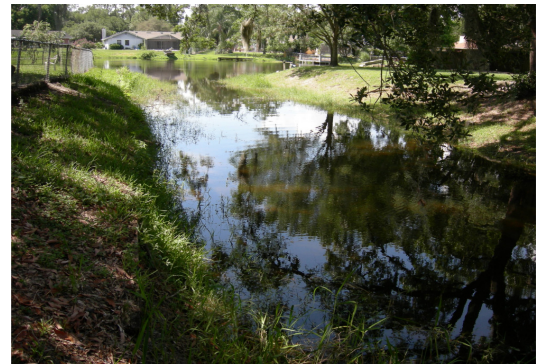
Figure 5-5 Lake Doll Connection

Each area mentioned in Section 4 for possible wetland plantings was visited on June 6, 2015, and planting a littoral zone around Lake Doll as well as the channel connecting Lake Doll to Lake Daisy appears to be the most readily implementable wetland planting option for the Lake Daisy Watershed (Figure 5-5). The finger canal at the north end of the lake just east of Lake Doll and south of Lake Daisy Road contains a concrete wall along much of its length on the east side and is therefore not as “littoral zone-ready” as Lake Doll. Jones Edmunds staff spoke to one of the residents and confirmed that neither Lake Doll nor the connecting channel support boat traffic. The total length of littoral zone (perimeter of lake and channel) is approximately 2,200 feet. Assuming a width of 12 feet equates to a total littoral zone area of about 0.6 acres. The approximate probable cost of this BMP is \$12,000.

- Replace much of the Polk County-owned boat ramp with pervious pavement.
- Plant a littoral zone around Lake Doll as well as the channel connecting Lake Doll to Lake Daisy.

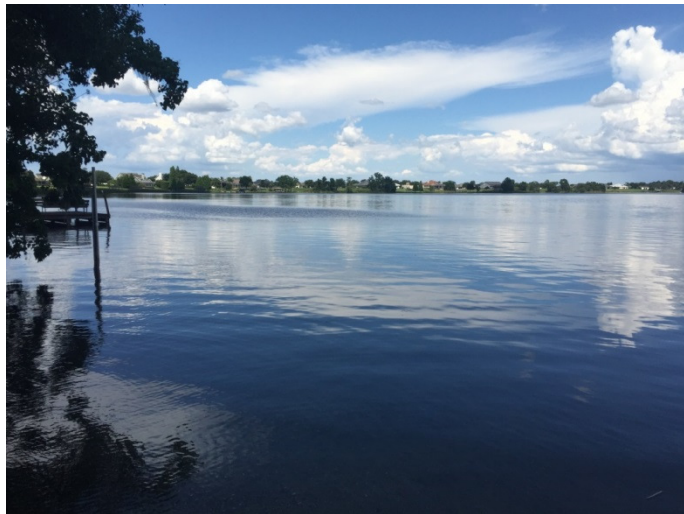
Depending upon logistics and budgeting, it may be best to conduct both in situ and laboratory analyses for estimation of nutrient fluxes, providing two distinct estimation methods. Laboratory measurements entail collecting sediments from the selected sites, typically accomplished using a pole corer, transporting the core samples to the laboratory where they are placed in an incubator, and collecting samples from the incubator at appropriate intervals for gas analysis. In situ measurements involve placing chambers on the lake bottom, with samples siphoned from the chambers at set intervals for analysis. Both the laboratory and in situ measurements provide nutrient flux and sediment oxygen demand estimates, which will aid in estimating the internal loadings to the lake.
